Structures Technical Memorandum 321

STRAIN MEASUREMENTS ON MIRAGE WING SPAR WITH BFRP
PATCH FITTED TO DRAIN-HOLE REGION

B.C. HOSKIN and A.A. BAKER

JULY 1980

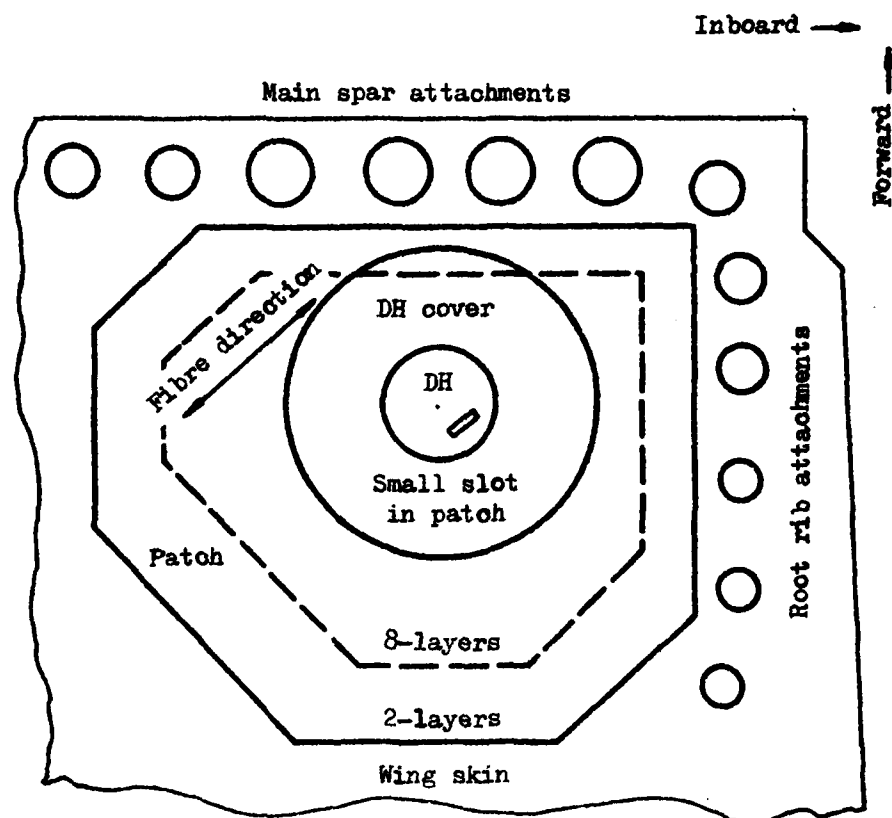
FIG.1 BFRP PATCH FOR DRAIN HOLE REGION OF STRAIN SURVEY WING
(approx. half scale)

The BFRP patch was fitted to the left wing of the Mirage which was being utilised in the ground-loading strain survey conducted at Avalon, Victoria. The location of the patch (on the external surface of the lower wing skin) is as shown in Fig. 1. The patch is stepped in thickness, one layer of BFRP at a time, from a minimum of two layers to a maximum of eight layers; each layer of BFRP is approximately 0.13 mm thick. Whilst the diameter of the drain hole in the skin is 32 mm, there is no such matching hole in the patch; instead the patch has a small slot 12 mm X 3 mm in it. (This modification was accepted by the RAAF.) The patch does have the eight holes (each of approximately 4 mm diameter and not shown in Fig. 1) which permit the bolting on of the standard metal drain hole cover and drainage nozzle; this last is sometimes referred to as the "decant boss". The patch was bonded to the wing using a cold setting adhesive, namely, CIBA AY105, HY956; contact pressure was applied to the patch during the bonding. A view of the patch as fitted to the wing is shown in Fig. 2.

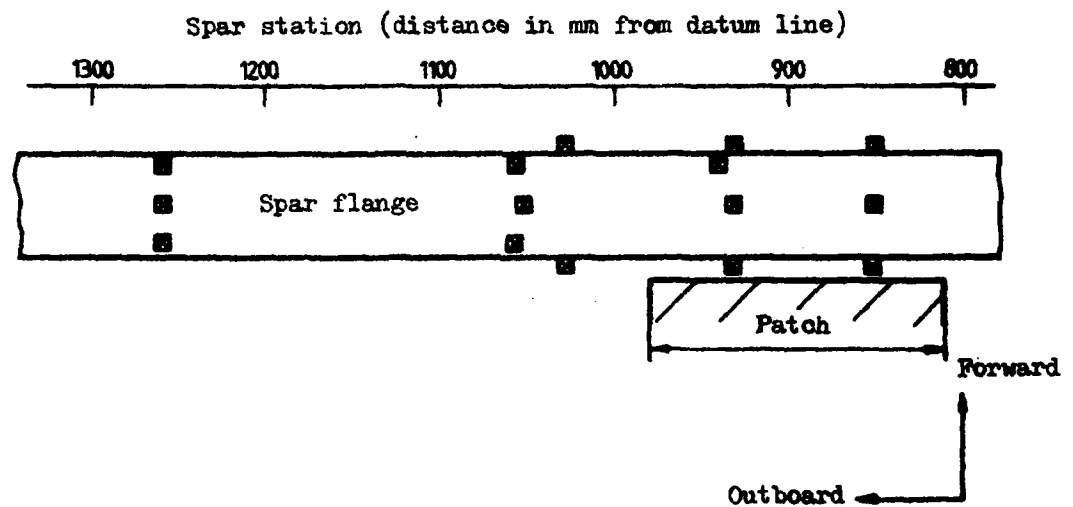
FIG.3 LOCATION OF STRAIN GAUGES ON LOWER SPAR FLANGE OF TEST WING.

The main spar of the test wing had fifteen electric resistance strain gauges fitted to its lower spar flange between stations 850 and 1260. (Spar stations are actually the distances in mm outboard of the fuselage centreline. The BFRP patch extends in the spanwise direction from station 810 to 980.) Gauges were variously fitted on the front (two possible positions), centre (one possible position) and rear (two possible positions) of the spar flange as shown in Fig. 3a. The spanwise positioning of the gauges is shown in Fig. 3b. Complete details on gauge locations are given in ref. 1. All gauges measured tensile strains in the spanwise direction.

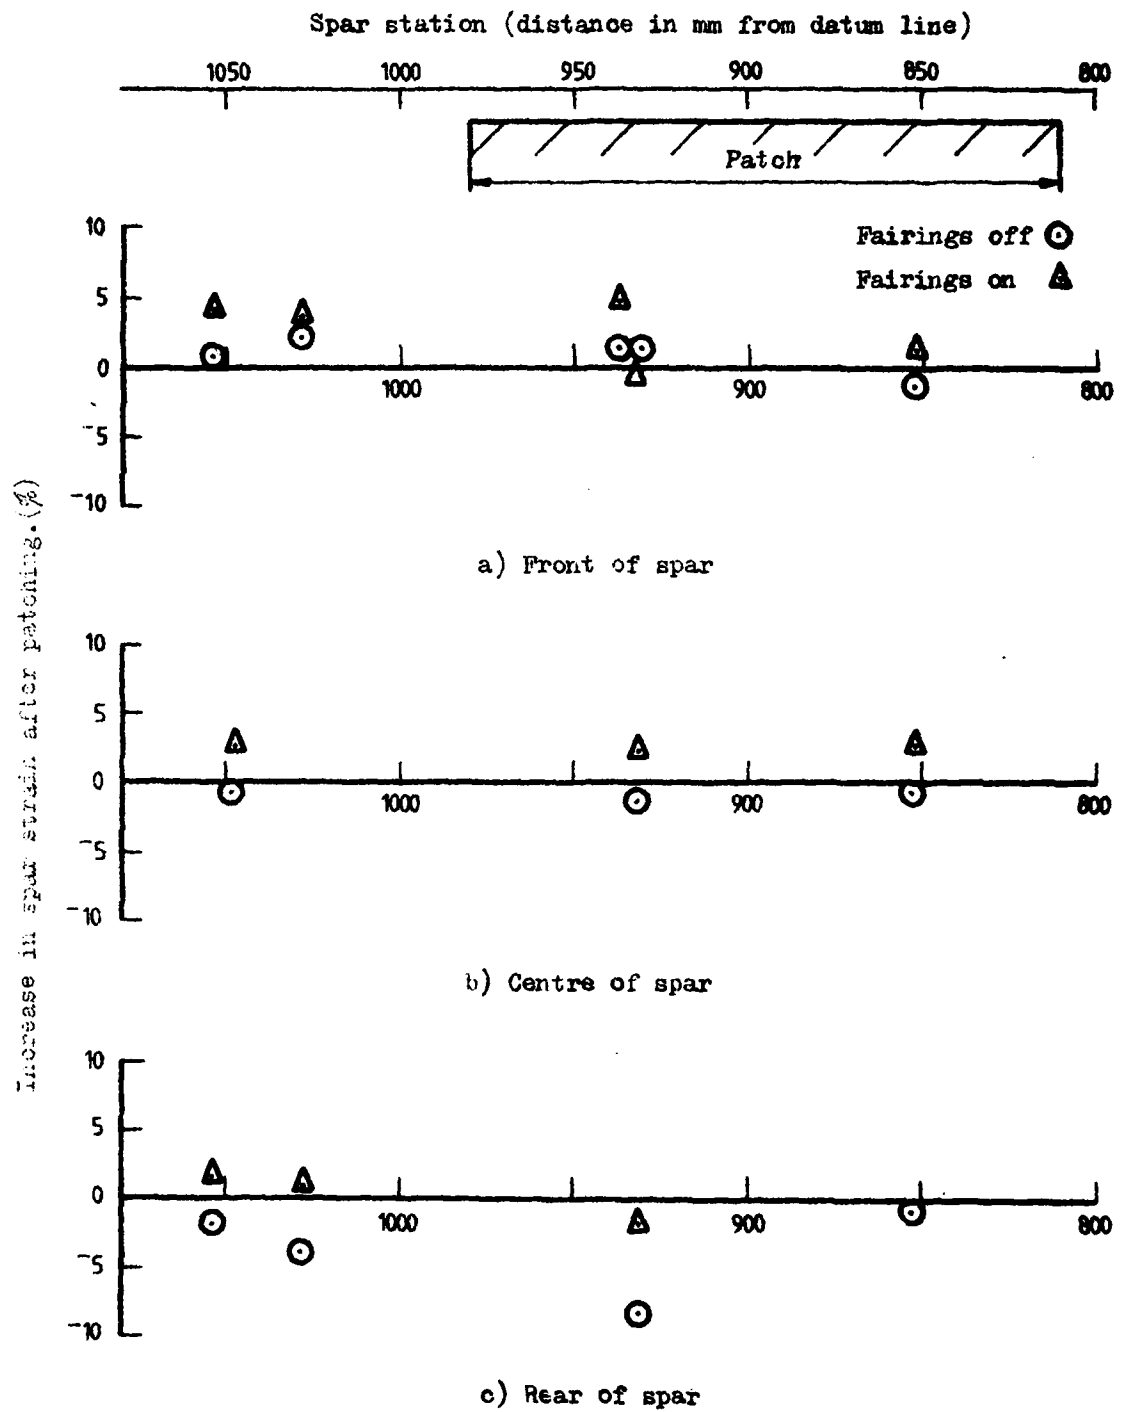
FIG.4 CHANGE IN SPAR STRAINS AFTER PATCHING; LOAD AT MAIN STORE POSITION.

The results are shown in Tables 1 and 2, where all strains have been cited as microstrains. In all cases the strain as actually measured at the maximum applied load has been standardised to the value corresponding to an applied load of 9.80 kN (1000 kgf); this standardisation was made on the assumption of a linear variation of strain with load. Corresponding values of strain before and after patch application are shown alongside one another, and the percentage increase in strain after patching has also been calculated. This last is defined as $((\text{patched value} - \text{unpatched value}) / \text{unpatched value}) \times 100$. The percentage increase in measured strain is also shown in Figs. 4 and 5. (For convenience of presentation, the results for the three gauges at station 1256 - which is well beyond the end of patch - have been omitted from Figs. 4 and 5).

Considering first the case of "fairings off", the maximum increase in measured strain anywhere is 2.5% at gauge 324T for loading at the Sidewinder position. With the exception of this result, and the measured decreases of 8.8% and 8.6% at gauge 323.2T, and 4.1% and 3.2% at gauge 1.7T, all other measured changes lie within the range +2.5% to -2.5%. In fact the only other increase in excess of 2% is for gauge 1.6T (Table 1).

For the case of "fairings on", the maximum increase in measured strain is 4.8% at gauge 323.4T for loading at the main store position. There are also several other apparent increases in excess of 2.5%, including two such results for the gauges at station 1256 (Table 1). However, it should be stated that experience in strain measurements on the Mirage wing has shown that the degree of tightening of the fairing attachment bolts affects the spar strains in the "fairings on" cases. This was not fully appreciated at the time some of these tests were done and, bearing in mind the relatively small differences that are being measured, there are doubts as to whether the apparent increase in spar strain at some locations can be properly attributed to the presence of the patch. For example, on intuitive grounds, it

would seem unlikely that the patch should have a significant effect on the strains at station 1256 yet, according to Table 1, there is a 3.6% increase in gauge 2T. (Note that the maximum measured change at station 1256 for the "fairings off" case is -1.4%.) For the above reasons, the measurements made in the "fairings off" cases are considered to be more reliable as indicators of any effect due to patching. However, even taking the results for the "fairings on" cases at their face value, the measured increases are still considered small.

The apparent large decrease in the strain at gauge 323.2T in three out of the four cases is somewhat surprising, although of no cause for concern because it is a decrease.

In discussions with the RAAF (ref. 2), it was agreed that the criterion for acceptance of the patch as far as any possible effects on spar strains go, was that the increase in strain after patching should not exceed 5%. In the case of results obtained with "fairings off", and these results are considered the most reliable, the maximum increase in strain after patching was found to be 2.5%. For what are considered the less reliable results, with "fairings on", the maximum increase was 4.8%. Hence, in both cases, the 5% criterion is satisfied.
